PROPERTY REPORT

Property Name: First Presbyterian Church of Cranbury **Ownership:** Private
Address: 22 S MAIN ST **Apartment #:** **ZIP:** 08512

Survey Name: Cranbury Local Historic District Survey 2018

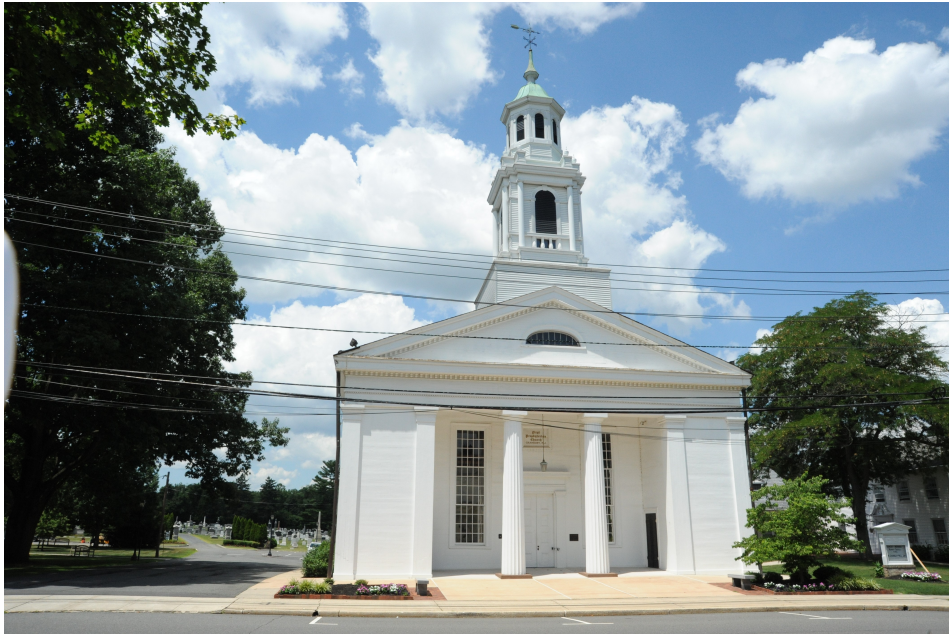
Property Photo:

The main, 1839/1859, rectangular-plan, Greek Revival-style, frame, gabled church building is backed on the northwest by a lower, 1 bay-deep, gabled, centered, 1936 chancel flanked on the northeast and southwest by 1-story, shed-roofed secondary volumes. A square-plan steeple in 2 main sections rises near the southeast end of main nave volume. The main, southeast elevation, facing S. Main Street, is finished in stucco to resemble stone, and presents an entrance in antis with 2 monumental Doric columns the main, centered entrance includes a double-leaf, recessed panel, historic wood door and surround with an architrave and historic pilasters. The architrave, in 2 sections, includes a dentiled course. The doorway is surmounted with a recessed panel in a frame with the name of the building. The doorway is flanked by tall windows with triple-hung, wood windows with 20 lights per sash. Smaller doors give access to the side aisles in the small walls in the outer parts of the entry. The relatively simple pediment includes cornices with both small and larger dentils and a broad, basket handle-arch window in the pediment. The clapboard-clad steeple includes segmental-arch, louvered openings in both levels. The lower level rises to a cornice with corner returns and a parapet topped with urns. The upper, octagonal-plan level rises to a copper-clad roof topped in turn by a pinnacle with a weather vane. The northeast and southwest, side elevations of the nave volume are

fenestrated in the triple-hung windows with 18-light, wood sash in most locations. The chancel is primarily fenestrated in 6/6, double-hung windows in most locations. The side and rear elevations are clad in painted clapboard. The chancel volume includes secondary doorway with a replaced door in the southeast bay of the southwest elevation of the chancel side volume. The rear elevation of the main volume is lit at the top level by quarter-round windows with historic, multi-light sash.
