## PROPERTY REPORT

**Property Name:** 38 South Main Street **Ownership:** Private  
**Address:** 38 S MAIN ST **Apartment #:** **ZIP:** 08512

**Survey Name:** Cranbury Local Historic District Survey 2018

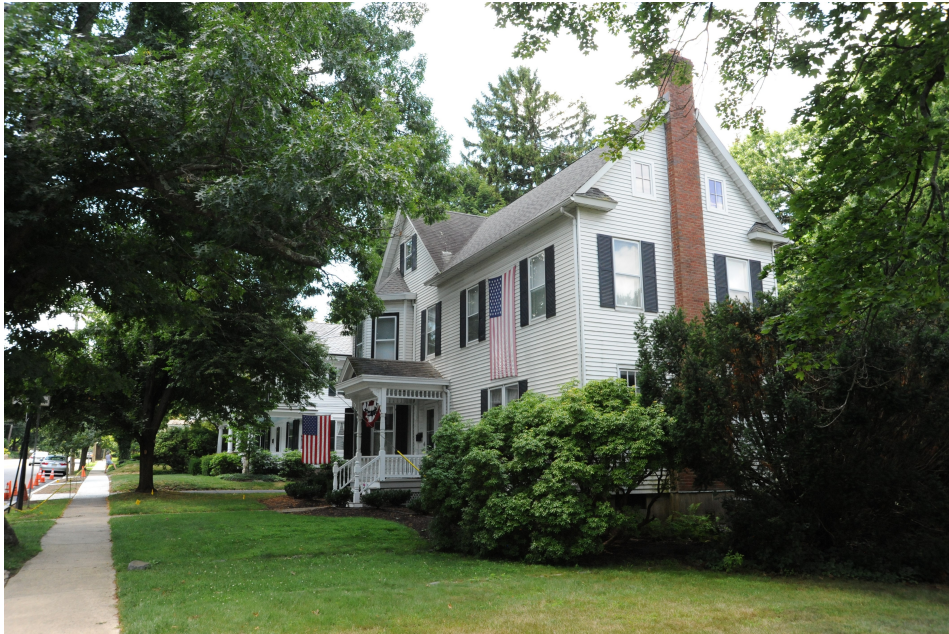
### Property Photo:

The 2 ½-story, gable-roofed, L-plan main block of this aluminum siding-clad, frame dwelling on a parged foundation is 2 bays wide and 3 bays deep and is fronted on the southeast elevation by a 1-story, 1-bay pedimented entry porch and backed on the northwest elevation by a 2-story, gable-roofed volume. The portion of the main volume that projects to the northeast of the porch is a ca. 1935 addition. A 2-story, hip-roofed, 3-sided projecting bay is located in the southwest bay of the southeast elevation of the main block. Historic, 2-story, 2-bay gabled pavilions flank the northwest-southeast oriented portion of the main volume on the northwest. A lower, 2-story secondary volume backs the main volume on the northwest, and is flanked on the southwest by a 1-story, shed-roofed porch. A 1-story, shed-roofed rear porch flanks the southeast bay of the southwest elevation of the rear volume. Recent aerial photographs indicate that a 1-story addition not visible from the public right-of-way is located at the northwest corner of the building. The roofs are predominantly clad in asphalt shingle and the windows predominantly have 1/1, double-hung, wood sash. An interior brick chimney projects from the northwest bay of the main block and an exterior brick chimney projects from the northeast elevation of the side volume. The pedimented front porch includes historic turned posts, a historic rail with historic balusters, historic shaped brackets, and a historic spindle frieze. The primary entrance, accessed by the porch, includes a historic door with large single light over recessed panels. The bays of the projecting bay and

second floor are regularly fenestrated. The projecting bay retains a historic pent eave and historic shaped shingle cladding on the pent eave and first floor. The southeast elevation of the main volume is lighted by a double window on the first floor and 2 single windows on the second floor. The northeast, side elevation of the main volume is regularly fenestrated with 2 fixed 4-light windows on the third floor. The southwest, side elevation is regularly fenestrated. A secondary entrance, accessed by the rear porch, is located on the southwest elevation of the rear volume. The third floor of the pavilions are lit by historic, 2/2, double-hung wood sash. The northwest, rear elevation is not visible from the public right-of-way. A 1 1/2-story, gable-roofed, concrete block and frame garage is located to the southwest of the residence.
