PROPERTY REPORT

Property Name: 127 North Main Street

Survey Name: Cranbury Historic Sites Survey Phase III

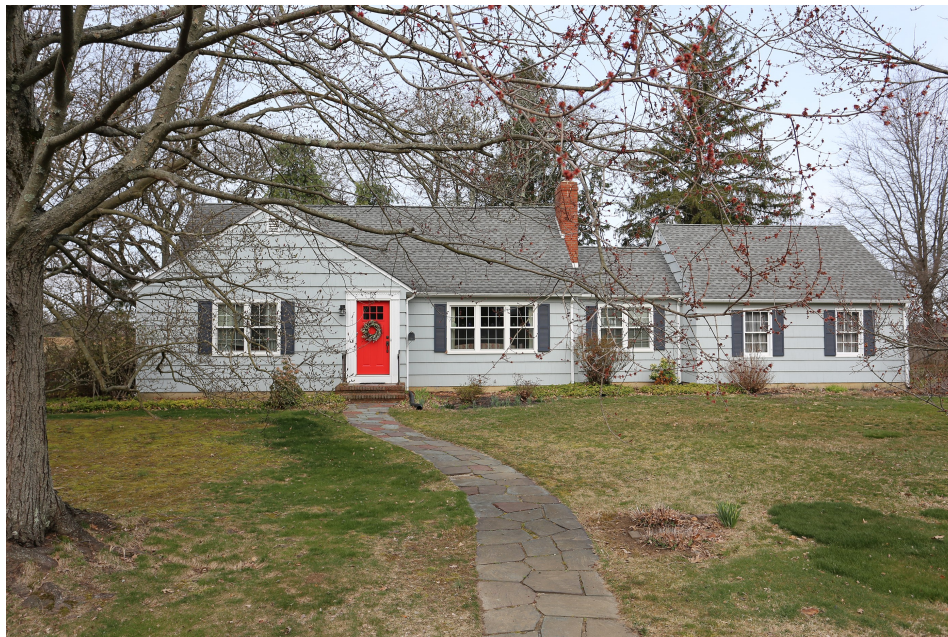
Property Photo:

127 North Main Street is a one-and-one-half-story-tall, three-bay-wide, three-bay-deep, frame dwelling built circa 1951 in the Minimal Traditional style. The dwelling consists of a three-bay-wide, side-gable-and-wing main block with a one-story-tall, two-bay-wide, attached garage connected to the northeast of the main block by a central, one-story-tall, one-bay-wide wing. A shed-roof dormer projects from the rear (northwest) roof slope of the main block and an exterior brick chimney extends above the northeast gable end of the main block. The roof is sheathed in asphalt shingles. The exterior of the dwelling is clad in machined shingles. Metal louvered vents are located in the northeast and southwest gable ends of the main block. Windows consist of six-over-six, vinyl-sash replacement units flanked by inoperable, louvered vinyl shutters throughout. Located in the center bay of the main block and below the front-gabled wing, the primary entrance contains a six-light vinyl sash door set within a wood surround with fluted pilasters (historic, likely original). A small brick stoop with metal handrails provides access to the entrance. A secondary entrance with wood steps is located on the rear elevation of the central wing but was not readily visible from the public right-of-way. The dwelling sits atop a concrete foundation.

A one-story, side-gabled, frame shed, constructed circa 1960, stands approximately 35 feet northwest of the dwelling but is not readily visible from the public right-of-way. A circa-2015, vinyl shed stands north of the dwelling.

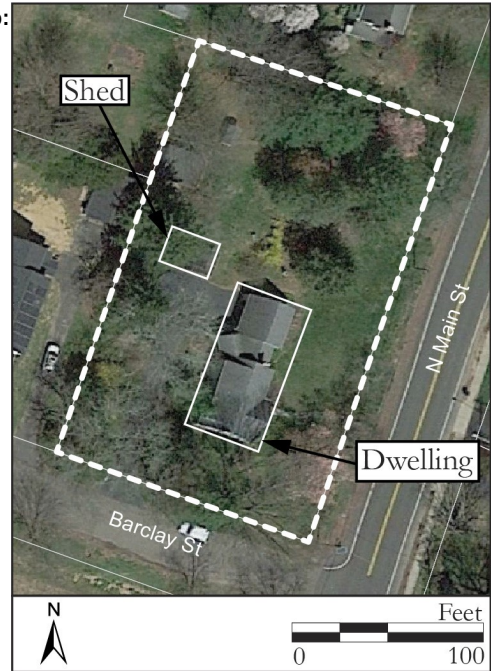
Site Map:

127 North Main Street is sited on a rectangular parcel (Block 25, Lot 23) located on the northwest side of North Main Street, at the northwest corner of its intersection with Barclay Street, in Cranbury Township, Middlesex County, New Jersey. The dwelling is oriented

with its primary elevation facing southeast and is set back approximately 60 feet from North Main Street. An asphalt-paved driveway extends along the northwest border of the property. A stone path leads from North Main Street to the primary entrance. Mature trees and shrubs are planted within close proximity to the dwelling. The subject property is located in a residential neighborhood surrounded by properties dating from the mid-nineteenth to the late twentieth centuries.
