PROPERTY REPORT

Property Name: 2 Barclay Street **Ownership:** Private
Address: 2 Barclay ST **Apartment #:** **ZIP:** 08512

Survey Name: Cranbury Historic Sites Survey Phase III

PROPERTY REPORT: PHOTO CONTINUATION SHEET

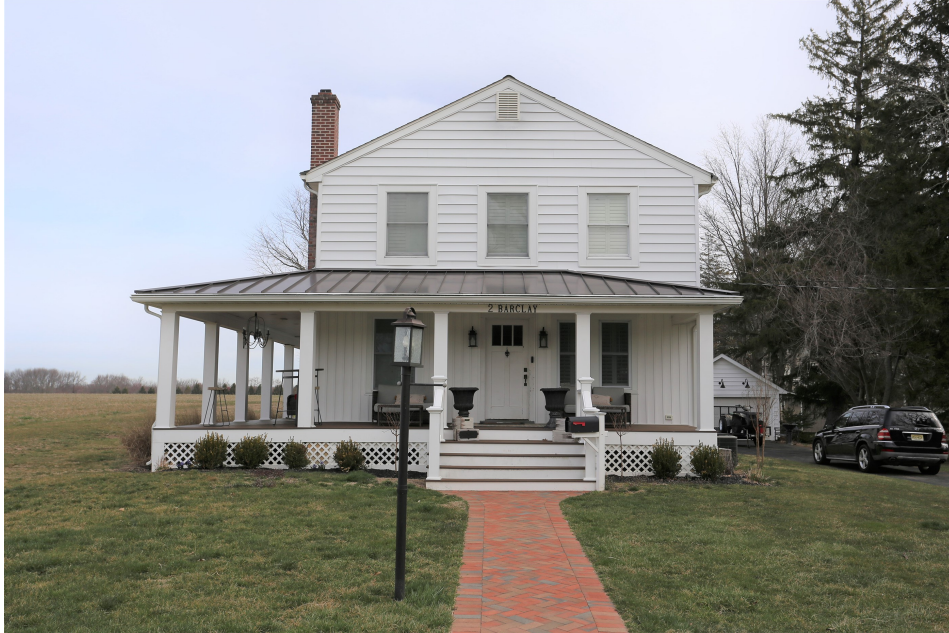
Property Photo:

2 Barclay Street is a two-story-tall, three-bay-wide, three-bay-deep, frame dwelling built circa 1929 as a one-story Bungalow and raised to two stories in the 1980s. The dwelling consists of a front-gabled main block and a one-story-tall, three-bay-wide, gable-roof addition on the rear (northeast) elevation (built circa 2019). An exterior brick chimney extends above the northwest elevation and an interior brick chimney pierces the roof ridge of the main block. The roof is sheathed in asphalt shingles. The exterior of the dwelling is clad in vinyl siding, with vinyl board and batten on the first floor of the primary (southwest) and northwest elevations. Windows generally consist of single and paired, vinyl-sash replacement units set within vinyl surrounds. The central, primary entrance contains a wood panel door with three lights (possibly original). A one-story, wraparound porch extends along the primary and northwest elevations (built circa 2019). The porch has a hipped roof covered with standing-seam metal panels and is supported by square vinyl posts. Vinyl railings flank the central stairway providing access to the porch. Centered on the southeast elevation is a one-and-one-half-story, front-gabled projecting bay. A secondary entrance is located on the southeast elevation of the rear addition. Sheltered by a front-gabled portico and accessed by a small wood deck, it contains a metal storm door and a modern wood door. The rear elevation is not visible from the public right-of-way. The dwelling stands atop a parged foundation.

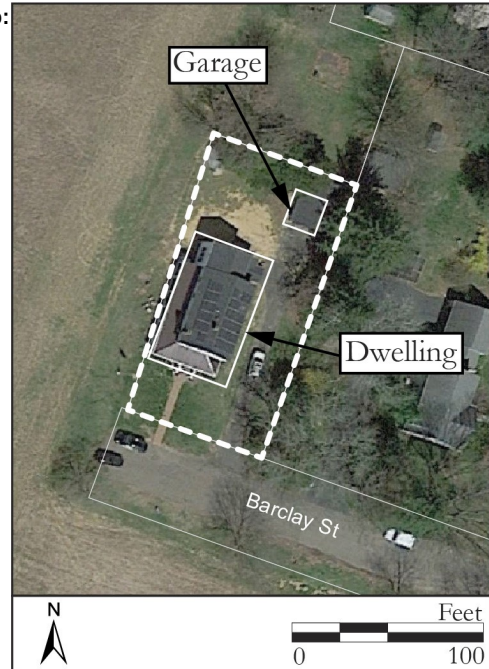
Site Map:

2 Barclay Street is sited on a rectangular parcel (Block 25, Lot 24) located on the northwest of the side of Barclay Street in Cranbury Township, Middlesex County, New Jersey. The dwelling is oriented with its primary elevation facing southwest and is set back approximately 45 feet from the road. An asphalt driveway extends along the southeast border of the property and leads to the detached garage. A brick path leads from the roadway to the primary entrance. Shrubs are planted within close proximity to the dwelling. The subject property is located in a residential neighborhood surrounded by properties dating from the mid-nineteenth to the late twentieth centuries.
