PROPERTY REPORT

Property Name: 148 North Main Street
Address: 148 N Main ST

Survey Name: Cranbury Historic Sites Survey Phase III

PROPERTY REPORT: PHOTO CONTINUATION SHEET

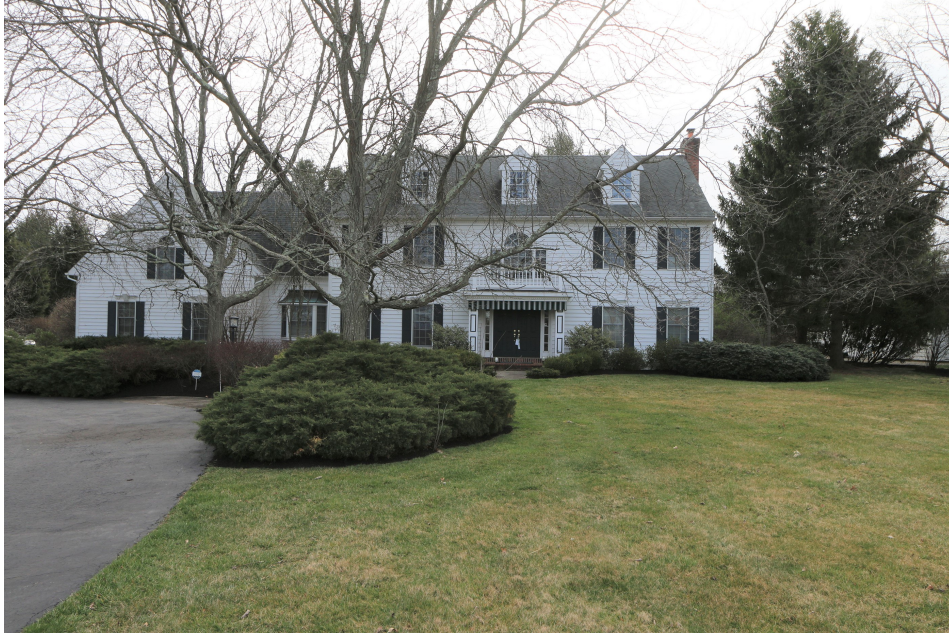
Property Photo:

148 North Main Street is a two-and-one-half-story-tall, five-bay-wide, two-bay-deep, frame dwelling constructed circa 1989 in the New Traditional Colonial Revival style. The dwelling consists of a side-gabled main block with a one-and-a-half-story cross-gabled, attached garage to the northeast, and two, one-story and two-story, shed-roof, rear (southeast) wings. Three, symmetrically placed gabled dormers interrupt the northwest roof slope of the main block and an exterior, brick chimney is centered on the southwest elevation. A central, gable-roof wall-dormer interrupts the northeast roof slope of the wing. Asphalt shingles cover the roof throughout and a dentillated frieze board accents the roof line on the primary (northwest) elevation. The exterior of the dwelling is clad in wood clapboard siding. Windows are all double-hung, vinyl-sash units with screens. Inoperable, louvered vinyl shutters flank the windows on the primary and southwest elevations. The primary elevation of the main block has symmetrical fenestration with a Palladian window centered on the second floor and decorative wood lintels with keystones above the windows on the first floor. The primary entrance is located in the center bay and contains double-leaf panel doors flanked by five-light sidelights. Sheltering the entrance is a low-sloped, hipped-roof portico supported by paneled, square wood posts. The roof of the portico features a dentillated cornice and is topped with a vinyl balustrade. A single bay window is located in the southernmost bay of the northeast wing and an arched transom is located above the window in the front-gable peak. The northeast elevation of the wing contains metal roll-top garage doors in the two eastern bays and a pedestrian entrance, consisting of a panel vinyl door, in the westernmost bay. A shed-roof addition. The rear (southeast) elevation is not visible from the public right-of-way.
