PROPERTY REPORT

Property Name: 12 Prospect Street
Address: 12 PROSPECT ST
Apartment #:
Ownership: Private
ZIP: 08512

PS&S recommends that 12 Prospect Street, perhaps constructed in the mid-19th century and altered multiple times, is a non-contributing property in the Cranbury Historic District.

Survey Name: Cranbury Local Historic District Survey 2018

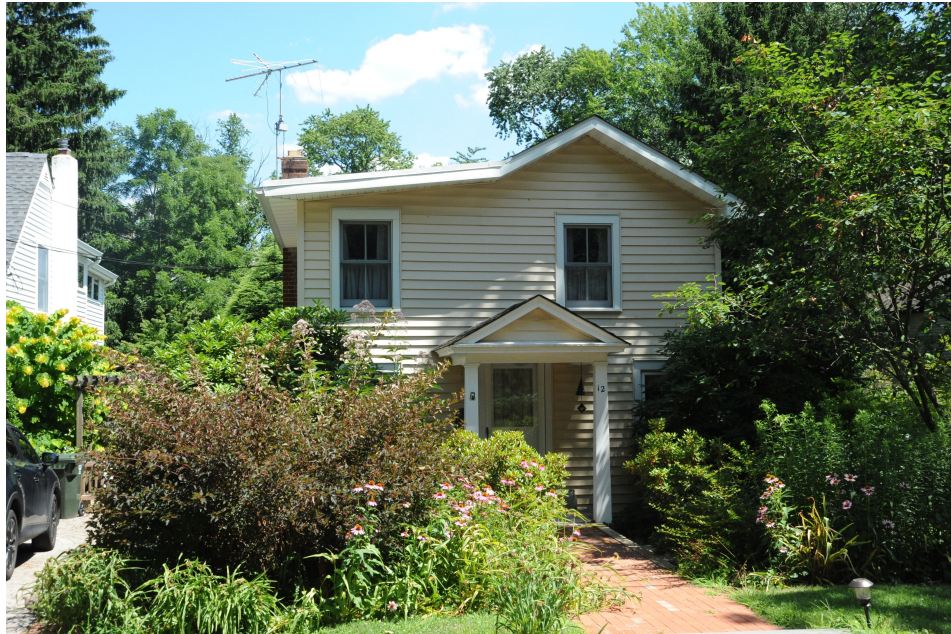
Property Photo:

The 2-story, gable and shed-roofed, rectangular-plan main block of this aluminum siding-clad, frame residence is 2 bays wide and 4 bays deep and is fronted on the northwest by a 1-story, 1-bay, centered, gabled porch and backed on the southeast elevation by a 1-story rear el. The foundation is not visible from the public right-of-way. A 2-story, hipped and composite-roofed volume projects from the southeast bays of the southwest, side elevation. The roofs are predominantly clad in asphalt shingle and the windows predominantly have 2/2 replacement sash. An exterior brick chimney is located in the center of the northeast, side elevation. The pedimented porch includes historic replacement square-section posts. The primary entrance to the residence, located in the central bay of the northwest elevation and accessed by the porch, includes a historic door with a large single light over recessed panels. The remaining bays are asymmetrically fenestrated on both floors. The southwest, side elevation is asymmetrically fenestrated and includes staggered windows on the projecting volume. The projecting volume is accessed by a secondary entrance that includes a 4-light door, flanking windows, and a shed-roofed door hood with shaped brackets. The northeast, side elevation is asymmetrically fenestrated by fixed and sash windows. The southeast, rear elevation is not visible from the public right-of-way. A 1-story, gable-roofed, concrete block garage is located to the southeast of the residence.

12 Prospect Street is a non-contributing property by virtue of the extensive alterations after the period of significance that are visible from the public right-of-way, including the altered fenestration patterns, alterations to the historic massing, and the replacement of the window sash and siding materials.
