PROPERTY REPORT

Property Name: Sexton's House **Ownership:** Private
Address: 1-3 Westminster PL **Apartment #:** **ZIP:** 08512

Survey Name: Cranbury CLG Survey 2017

BUILDING ATTACHMENT

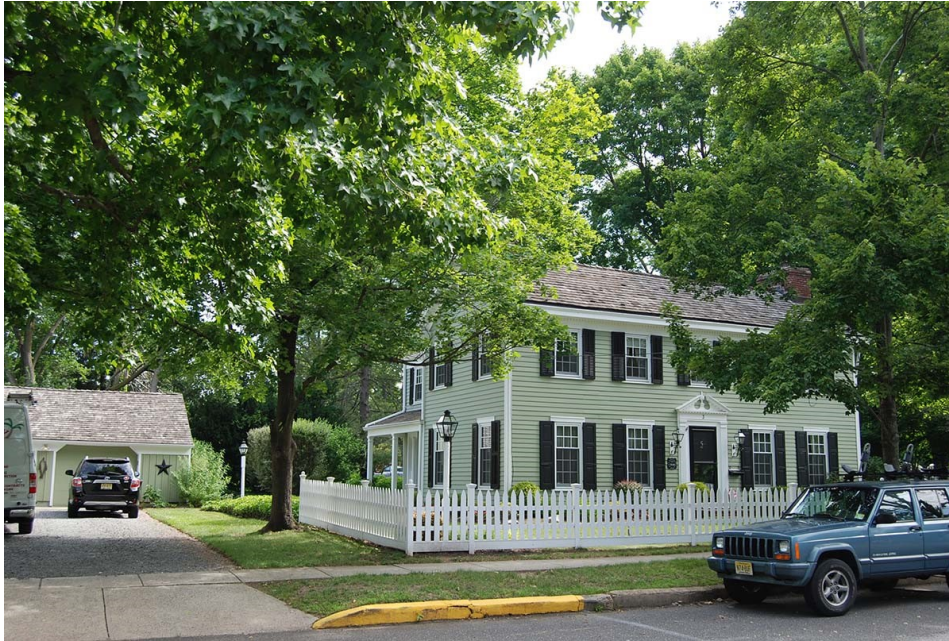
Property Photo:

The Sexton's House at 1-3 Westminster Place is a two-story tall, five-bay wide, two-bay deep, frame private residence constructed circa 1840 and altered extensively circa 1960 in a vernacular Federal style. The dwelling, which has a concrete foundation, consists of a rectangular, side-gabled main block; a two-story, two-bay rear ell; and a one-story, three-bay shed roof addition adjoining the main block to the northeast and the ell to the southeast. The dwelling is clad in wood clapboard siding on all elevations. The roof is sheathed with wood shingles. An exterior chimney is located at the southeast gable end of the main block. An interior brick chimney pierces the roof on the northeast bent of the main block. A wood frieze with dentil trim runs below a molded wood cornice (with a return cornice at the gable ends) on the main block. Regular fenestration on the front elevation consists of six-over-six, vinyl-sash replacement windows with louvered shutters on the second floor and six-over-nine, vinyl-sash replacement windows with paneled shutters on the first floor. The central entrance is a six-panel wood door with an aluminum storm door. The entrance is set within an elaborate molded wood surround featuring fluted pilasters and a broken pediment with dentil trim and a carved urn design. The entrance is accessed via a brick stoop. Windows on the southeast elevation of the main block, at the second floor on either side of the exterior brick chimney; are six-over-six, vinyl-sash replacement windows with louvered shutters. The rear ell also has six-over-six, vinyl-sash replacement windows with louvered shutters on the second floor. The first floor of the southeast elevation, comprising the one-story shed roof addition, has narrow fixed vinyl windows with ten inset lights each. A central secondary entrance consists of a single door with twelve inset lights above a rectangular panel. The rear

elevation features a louvered window in the gable end of the ell; six-over-six, vinyl-sash replacement windows with louvered shutters on the second floor; and a six-over-nine, vinyl-sash replacement window on the first floor. A square vinyl bay window with twenty inset lights and a standing seam metal cap perforates the first floor of the ell, west of the six-over-nine vinyl-sash window. Four narrow ten-light vinyl windows, adjoined in one unit, pierce the rear elevation of the shed roof addition. The northwest elevation of the main block features a louvered window in the gable end; six-over-six, vinyl-sash replacement windows with louvered shutters on the first floor; and six-over-nine, vinyl-sash replacement windows with louvered shutters on the second floor. The ell's northwest elevation has six-over-six, vinyl-sash replacement windows with louvered shutters on the second floor. An eighteen-light fixed vinyl window and a six-panel door with a segmented sidelight on the first floor are sheltered by a shed roof porch with a brick foundation, square columns, and a wood frieze. A one-story shed, constructed circa 2005 after the district's period of significance, is located east of the dwelling. A two-bay, side-gabled garage, constructed circa 1970, is located west of the dwelling.
