PROPERTY REPORT

Property Name: Uriah Dehart House **Ownership:** Private
Address: 60 N Main ST **Apartment #:** **ZIP:** 08512

Survey Name: Cranbury CLG Survey 2017

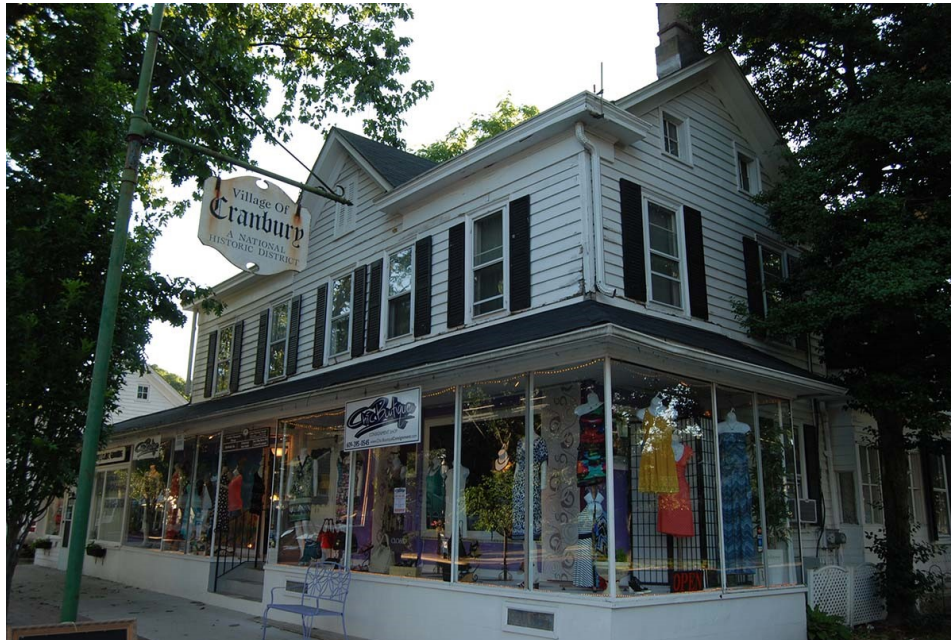
Property Photo:

The Uriah Dehart House at 60 North Main Street is a two-and-a-half-story, five-bay, two-pile, frame commercial building and private residence constructed circa 1845 and later renovated in the Gothic Revival style. The building has multiple rear additions and a freestanding frame outbuilding to the east.

The main block is the two-and-a-half story, five-bay Gothic Revival commercial building. Its cross-gabled roof is sheathed with asphalt shingles and features a centered cross-gable with a rectangular window sealed with louvered shutters. The house has a molded cornice that doubles as an interior gutter system over an expressed wood frieze. The house has wood clapboard walls on the main elevation. The second floor has five one-over-one, double-hung, wood-sash (replacement) windows with aluminum storm windows and louvered shutters. A protruding storefront below a pent roof occupies the first floor; it features large plate glass windows and a recessed entrance with a metal crossbuck screen door accessed via two concrete steps.

The south end of the original building faces Park Place East. The south end chimney is clearly visible. The molded cornice has returns at the eaveline, flanking two four-light attic windows (possibly original). The storefront wraps around this elevation and occupies the western half of the elevation. Fenestration on the end wall is balanced, with one-over-one double hung sash windows flanked by louvered shutters, with two on the second floor and one on the first floor. The north end of the building shares many of the same features. The roof is clad
