PROPERTY REPORT

Property Name: 42 North Main Street **Ownership:** Private
Address: 42 N Main ST **Apartment #:** **ZIP:** 08512

Survey Name: Cranbury CLG Survey 2017

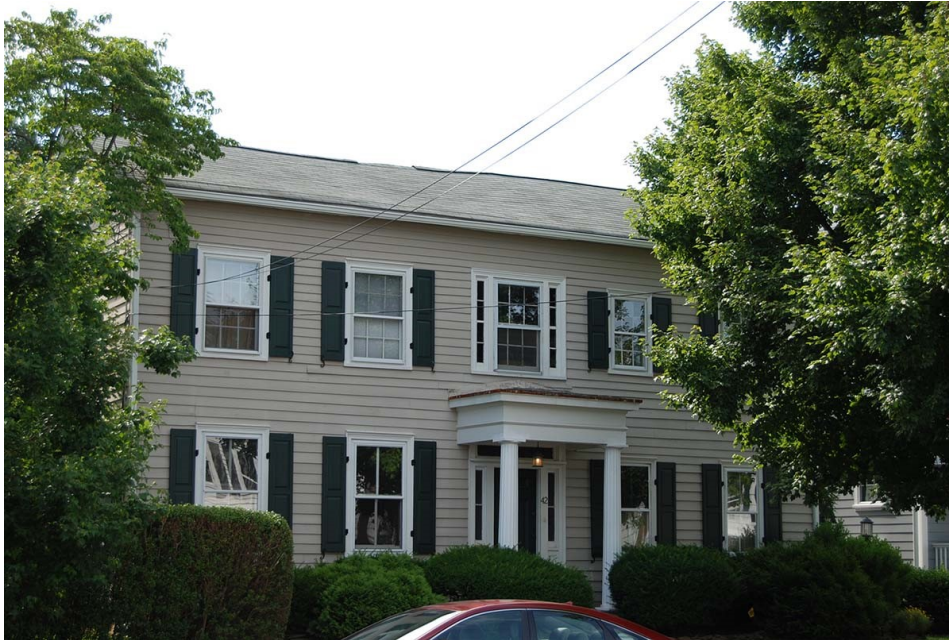
Property Photo:

42 North Main Street is a two-story tall, five-bay wide, two-bay deep, frame private residence constructed between 1820 and 1840 in a vernacular style. The dwelling consists of a rectangular, side-gabled main block; a two-story, one-bay ell (constructed by 1910); a two-story, two-bay hipped roof addition on the rear of the ell (constructed by 1910); and a one-story, one-bay addition to the southwest (constructed circa 1978). The roof is sheathed with asphalt shingles. An interior brick and stucco chimney is located in the southeast gable end of the main block. The main block has a molded wood return cornice in the northeast gable end only. The exterior of the dwelling is clad in wood clapboard siding on all elevations. On the front elevation, windows on the second floor are six-over-six, double-hung, wood-sash (likely original) with two-over-two, double-hung, replacement wood sash windows on the first floor. All windows have aluminum storm windows and molded wood trim. The central window on the second floor is flanked by four-light sidelights; all other windows have paneled shutters. The central historic entrance is a three-panel wood door with sidelights and a rectangular transom. A one-story entry porch with fluted Doric columns and a standing seam metal roof shelters the door. The northeast elevation features two square fixed wood windows, one louvered and one with four inset lights, in the gable end of the main block. Windows on the first floor of the main block are two-over-two, double-hung, replacement wood-sash windows with paneled shutters. The two-story ell has one-over-one, vinyl-sash replacement windows; the first floor is sheltered by a shed roof entry porch with square posts. The hipped roof addition has six-over-six, vinyl-sash replacement windows with three-light transoms. The southwest elevation features two square fixed wood windows, one louvered and one with four inset lights, in the gable end of the main block. A two-over-two, double-hung, replacement wood-sash window with paneled

shutters sits in the west bay on the first floor of the main block. The rear addition has one-over-one, vinyl-sash replacement windows and the hipped roof addition has six-over-six, vinyl-sash replacement windows with three-light transoms. Character-defining elements of the dwelling include the wood-sash window with sidelights on the front elevation and the entry porch.

The 1989 Heritage Studies survey identified 42 North Main Street as a contributing resource to the Cranbury Historic District. RGA concurs with the previous evaluation and recommends 42 North Main Street as a contributing resource due to its date of construction, design, and use of materials compatible with the district.

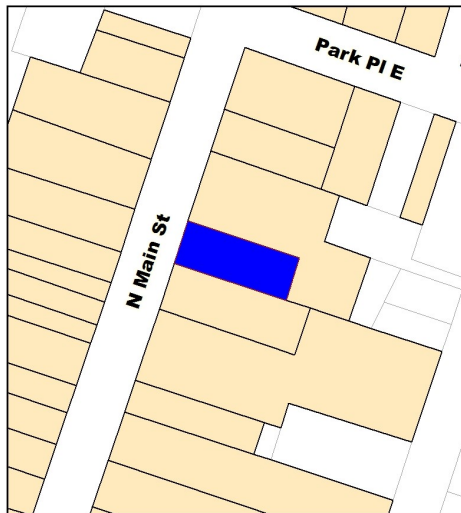
Site Map:

42 North Main Street is sited on a rectangular parcel (Block 32, Lot 4) located on the east side of North Main Street in Cranbury Township, Middlesex County, New Jersey. The dwelling is oriented with its primary elevation facing northwest and is set back approximately 15 feet from North Main Street. A concrete sidewalk, which runs along North Main Street, spans the west side of the parcel. Shrubs adjoin the front (northwest) elevation of the dwelling. The property is lightly wooded. 42 North Main Street is located in a mixed residential and commercial neighborhood surrounded by properties dating from the mid-nineteenth to the early twentieth century.
