PROPERTY REPORT

Property Name: 40 Maplewood Avenue **Ownership:** Private
Address: 40 MAPLEWOOD AVE **Apartment #:** **ZIP:** 08512

PS&S recommends that 40 Maplewood Avenue, constructed in the 1930s, is a contributing property in the Cranbury Historic District.

Survey Name: Cranbury Local Historic District Survey 2018

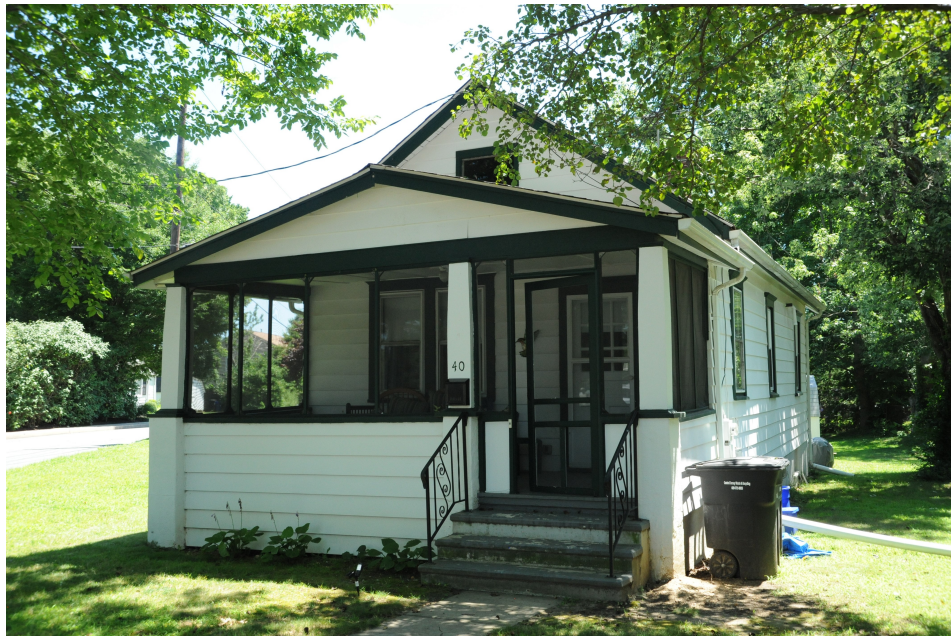
Property Photo:

The 1 1/2-story, gable-roofed, rectangular plan, clapboard-clad, bungalow on a parged foundation is 2 bays wide and 4 bays deep and is fronted on the northwest by a 1-story, gable-roofed, full-width porch. A 1-story, enclosed, rear porch is on the southeast elevation, and 2, 1-story, rectangular-plan bays project from the northeast, side elevation. The roofs are predominantly clad in asphalt shingle and the windows have 1/1, double-hung, historic wood sash. An interior brick chimney projects from the inner southeast bay of the southwest roof slope. The screened front porch is accessed by an added, straight concrete stair with wrought iron rails in the west bay and includes a clapboard-clad knee wall and tapered, square-plan posts with stuccoed bases. The primary entrance to the residence, located in the west bay, includes a historic 9-light, paneled wood door. The remaining bay is lighted by a double window, with a single window on the second floor. The southeast, side elevation is lighted by 3 windows. The southeast, rear elevation includes the enclosed porch in the east bay and a single window in the south bay. The northeast, side elevation includes a window in the northwest bay, a triple window in the central projecting bay, and jalousie windows in the rear projecting bay. A concrete stair provides access to the rear porch.

A 1-story, gambrel-roofed frame shed is located to the southeast of the residence.

This property is a contributing property in the historic district because it retains integrity and historic character-defining features such as its historic massing and fenestration patterns, historic wood clapboard cladding, historic wood windows, and historic porch details.
