PROPERTY REPORT

Property Name: 9 Station Road **Ownership:** Private
Address: 9 STATION RD **Apartment #:** **ZIP:** 08512

Survey Name: Cranbury Local Historic District Survey 2018

Organization: Paulus, Sokolowski & Sartor

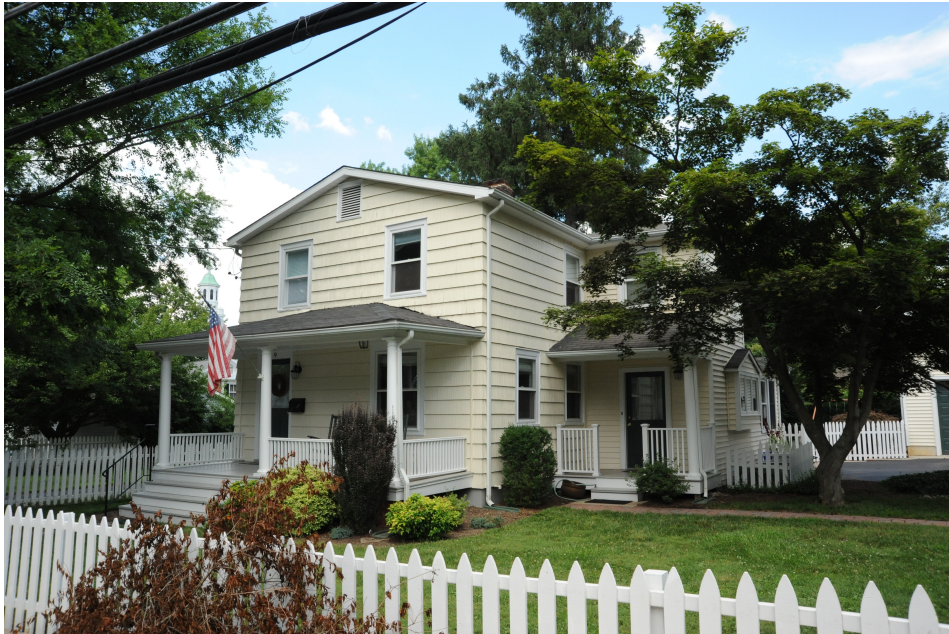
Property Photo:

The 2-story, gable-roofed, rectangular-plan main block of this asbestos shingle and vinyl siding-clad, frame dwelling on a parged foundation is 2 bays wide and 3 bays deep and is fronted on the south by a 1-story, hip-roofed, full-width porch. A 2-story, gabled addition flanks the main volume on the northeast and includes a 1-story, shed-roofed porch on the south, and is backed by a 1-story, enclosed historic porch on the north. A gabled oriel projects from the east elevation of the addition. The addition, enclosed porch, and rear half of the west elevation are clad in vinyl siding. The visible roofs are clad in asphalt shingle and the windows have 1/1 replacement wood sash. An interior brick chimney projects from the center of the west roof slope. An exterior, stuccoed chimney is located near the center of the west elevation. The front porch, accessed by a straight stair in the west bay, includes historic replacement Tuscan columns and a historic replacement rail with square-plan balusters. The primary entrance, located in the west bay of the south elevation, includes a historic replacement door with a large single top light. The remaining bays of both floors are regularly fenestrated. The south elevation of the addition, fronted by a porch with added column and added rail with square-plan balusters, includes an added, single-light secondary door, with a single window on the second floor. The east, side elevation is regularly fenestrated and is lighted by a triple casement window in the oriel. A double window lights the enclosed porch. The west, side elevation is regularly fenestrated except for the first floor of the south,

central bay. The north, rear elevation is not visible from the public right-of-way. A 1 ½-story, 2-bay, vinyl siding-clad garage is located northeast of the residence.

9 Station Road is a contributing property in the Cranbury Historic District because it retains the historic massing of the main block, historic fenestration patterns, and its historic front porch, including historic replacement porch columns and rail. However, the replacement of surface materials and the visibility of the added side volume from the public right-of-way render this status marginal.
