PROPERTY REPORT

Property Name: Cranbury Inn **Ownership:** Private
Address: 21 S MAIN ST **Apartment #:** **ZIP:** 08512

Survey Name: Cranbury Local Historic District Survey 2018

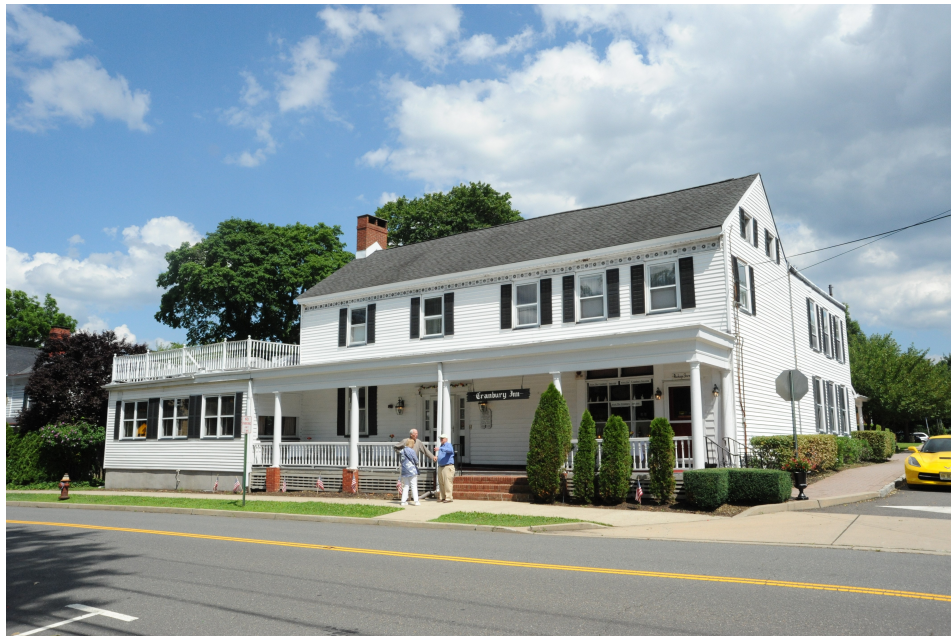
Property Photo:

The 2 ½-story, gable-roofed, rectangular-plan main block of this aluminum siding-clad, frame historic hotel on a parged foundation is 6 bays wide and 2 bays deep and is fronted on the northwest, main elevation by a 1-story, full-width, composite-roofed porch and backed on the southeast elevation by a 2-story, composite-roofed volume to the southwest and a 2-story, gable-roofed volume to the northeast. These are in turn backed by multiple additions: a 1-story hyphen links to a 1 ½-story, gable-roofed volume with extended gabled dormers, which is backed in turn by a large, 2-story, gable-roofed volume. A 1-story, composite-roofed side addition flanks the northeast elevation. The roofs are predominantly clad in asphalt shingle with a historic punch and gouge frieze on the northwest elevation of the main volume. The windows of the main volume predominantly have 1/1 replacement sash with applied shutters. An interior brick chimney projects from the northeast bay of the gable ridge. An interior stone chimney projects from the southwest slope of the gable-roofed, dormered rear volume. The front porch, accessed by a brick stair with wrought iron rails in the southwest, central bay of the northwest elevation and the single bay of the southwest elevation, includes replaced columns on brick piers, a historic rail, and replaced balusters. A single historic pilaster is located on the southwest corner of the hotel. The primary entrance is located in the northeast, central bay and includes a historic door with historic 3-light sidelights, fluted pilasters, and a historic dentiled cornice. A secondary entrance, labeled the Package

Store, is located in the southwest bay and is flanked to the northeast by a large, 9-light display window. A single window lights the northeast bay. The second floor is asymmetrically fenestrated by 5 single windows. The side volume, which projects further northwest than the main volume, is lighted by 3 double windows on the northwest elevation and a single double window on the southwest elevation. The southwest, side elevation of the main volume is lighted by a single window on the second floor and 2 smaller windows with historic window frames on the third floor. The composite-roofed rear volume is lighted by 3 windows on each floor. A secondary 15-light entrance is located in the southeast elevation hyphen. A single window lights an extended dormer in this volume. The gable-roofed, dormered volume includes a recessed porch with columns on stone piers and is accessed by 2 sets of double 15-light doors flanked by an 8/8 window, with 6/6 windows lighting the dormers. The 2-story rear volume includes a wall gable lighted by large multi-light fixed windows in the northeast bay and is regularly fenestrated with 6/6 windows on both floors of the remaining bays. The southeast, rear elevation of the volume is lighted on the second floor by a large, 3-sided, segmental arch, fixed window. The northeast, side elevation is not visible from the public right-of-way.

This property is a key-contributing property in the historic district because retains integrity and such key historic character-defining features as its historic massing and fenestration patterns, its open front porch, and historic doorway.
